ENGINEERING CASE LIBRARY

SPONTANEOUS FRACTURE (A)

FAILURE OF HEADWEAR HOLDERS

Owl Equipment Ltd.
Helen, Ontario

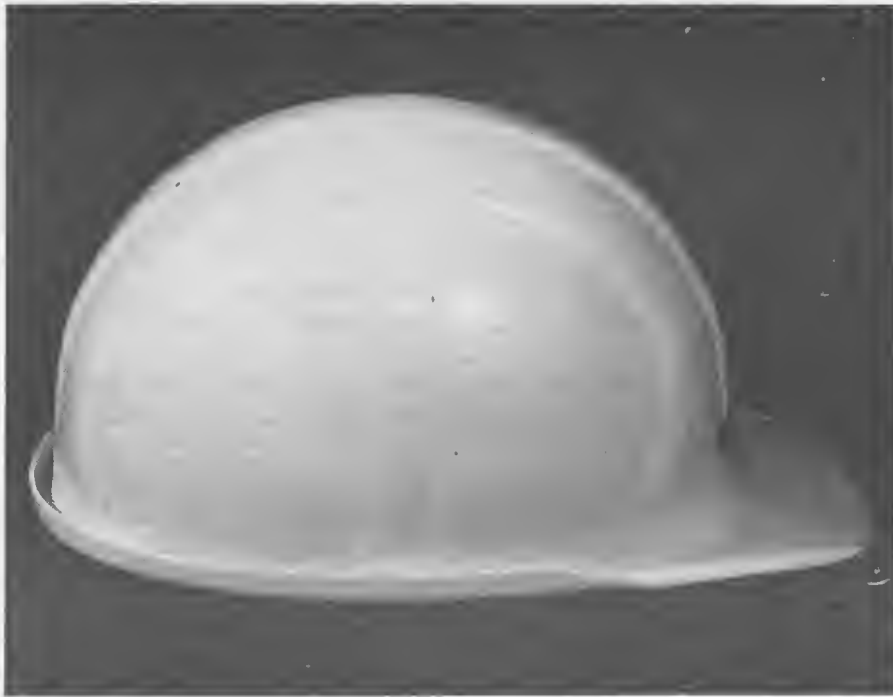
Figure 1

When Mr. J. A. Lami and Mr. Bowan turned up in my office they carried with them a number of the offending hard hats. (Figure 1) They introduced themselves respectively as the General Manager and the Chief Engineer of Owl Equipment Limited of Helen, Ontario.

HARD HAT

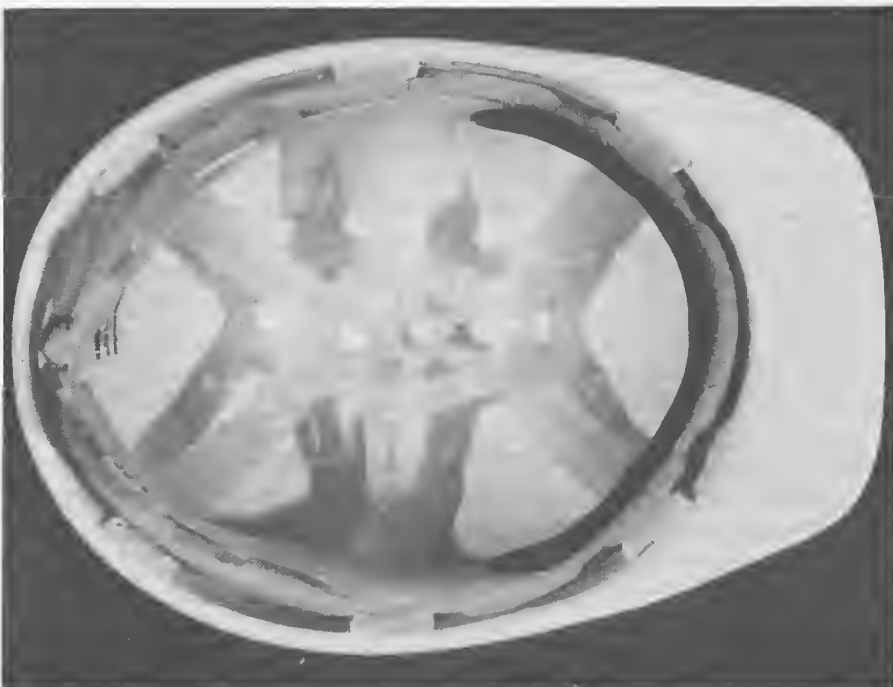
Figure 2

HARD HAT WITH HEAD HARNESS INSTALLED

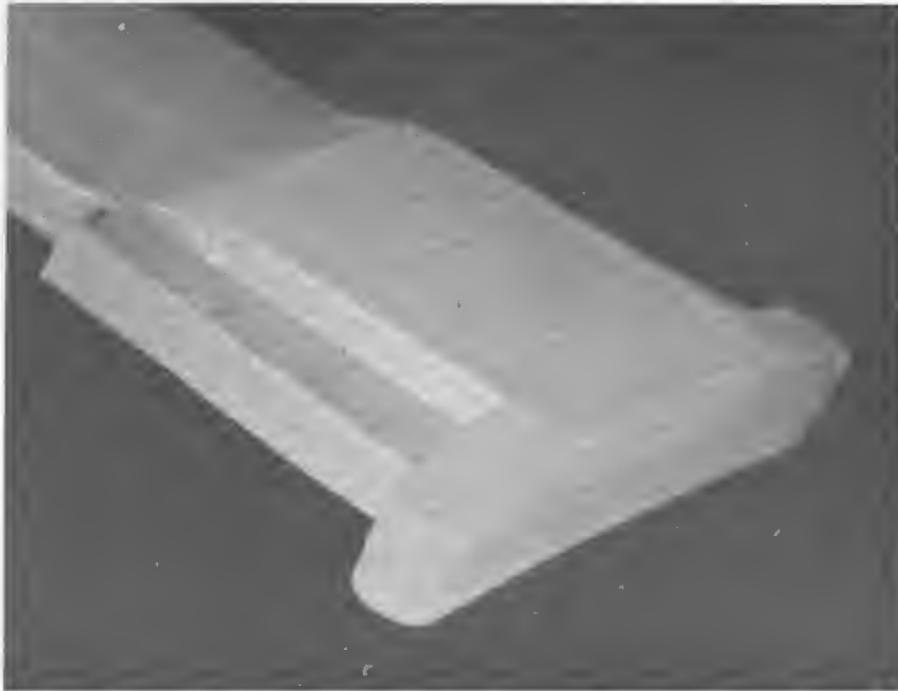
Figure 3

Because the nylon head harness is an interference fit in the holders, (Figures 3, 7, and 8) Mr. Lami and Mr. Bowan suspected that the right hand holder on the corresponding insert was oversize, resulting in overloading. They asked for my help in measuring the various parts to determine if their suspicions as to size were correct.

HARNESS INSERT

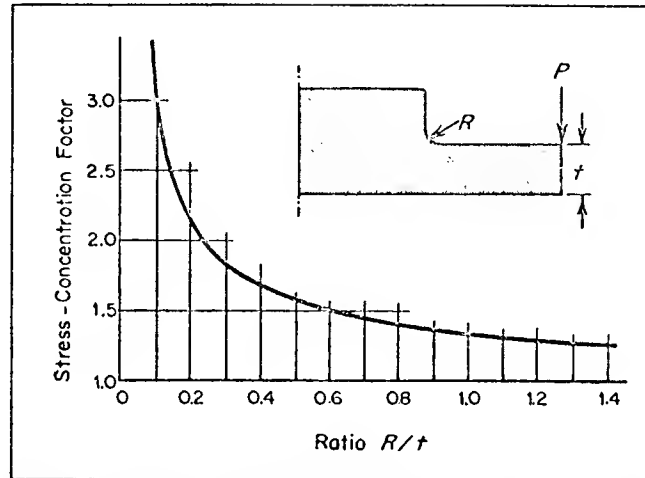
Figure 3

The geometry of the element is such that the section is thinnest at A as well as having a sharp re-entrant corner. Therefore, not only would the stress be maximum at the thin section but the sharp corner would give rise to stress concentrations of considerably greater than three (Figure 3). In addition, these stresses would be polyaxial.

Fig. 11—Effect of fillet radius on stress-concentration factor.
 P = applied load; R = fillet radius; t = section thickness.
Data, courtesy SPI.
